Corrosion of fasteners in heat-treated wood – progress report after two years' exposure outdoors.

Jöran Jermer and Bo-Lennart Andersson
SP Swedish National Testing and Research Institute
PO Box 857
SE-501 15 Borås, Sweden

**Paper prepared for the 36th Annual Meeting
Bangalore, India
24-28 April 2005**

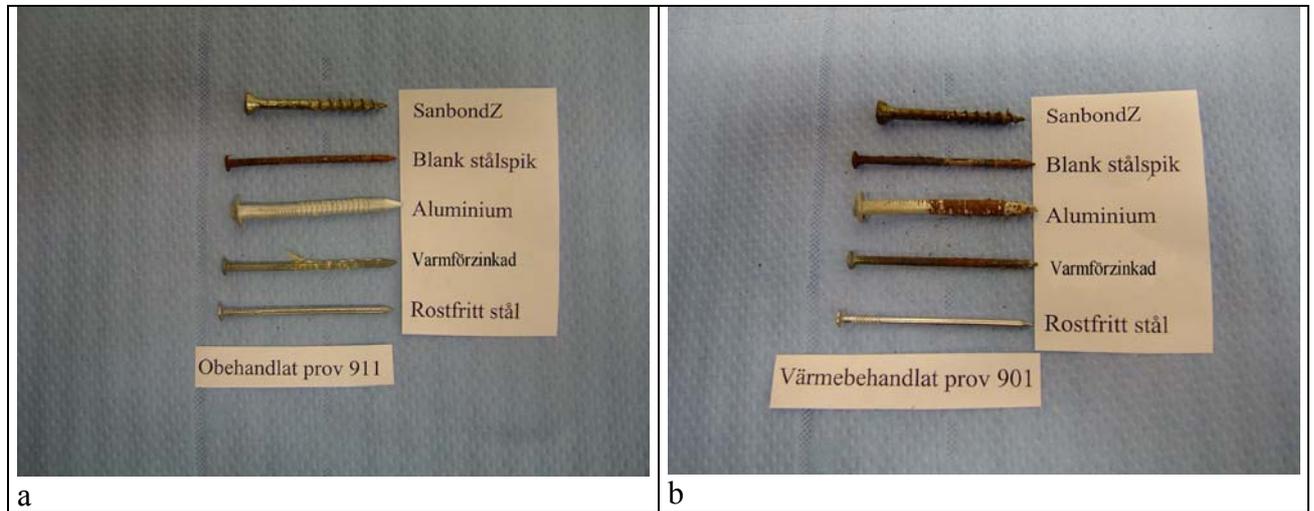
Figure 2. a) Fasteners exposed in untreated wood. b) Fasteners exposed in heat-treated wood

Stainless steel has performed best so far with basically no corrosion at all. Aluminium and Sanbond Z-coated steel has also performed fairly well, whereas mild steel has been severely

attacked in the heat-treated wood. Hot-dip galvanized steel has, surprisingly enough, been quite attacked in the heat-treated wood already after two years' exposure.

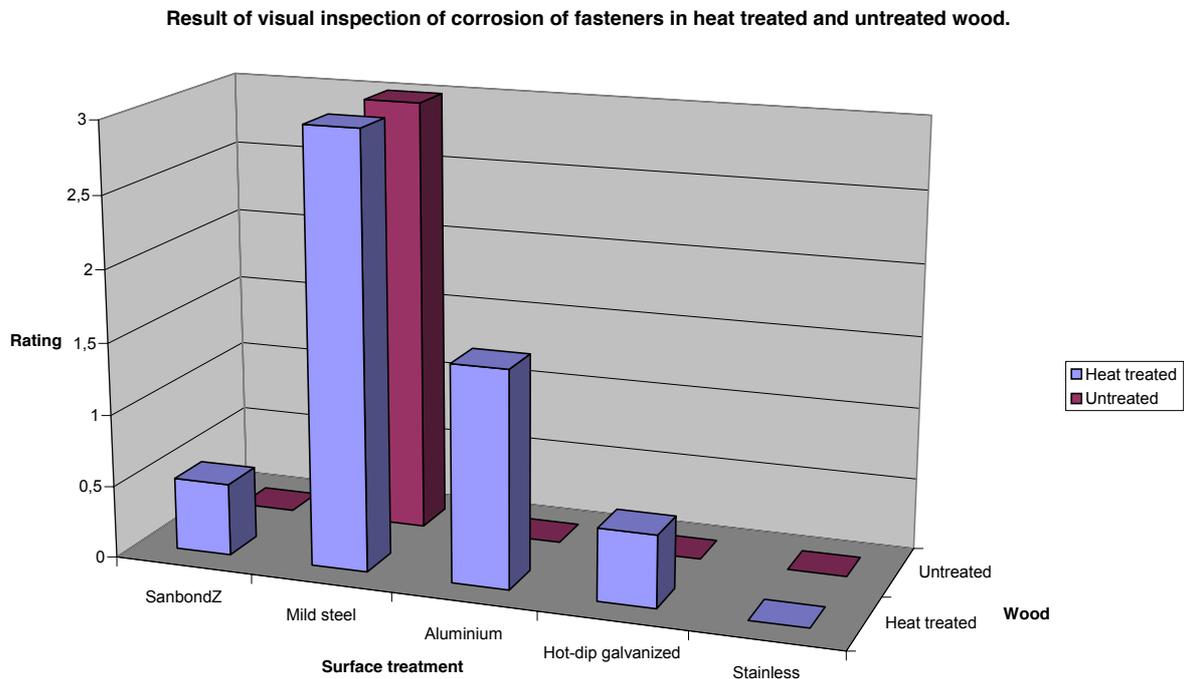
Figure 3. Result of visual inspection of corrosion of fasteners in heat-treated and untreated wood.

There was a fairly good correlation between the results of the visual assessment and the calculated depth of corrosion. However, the actual corrosion found for hot-dip galvanized steel was more severe than found at the visual inspection.

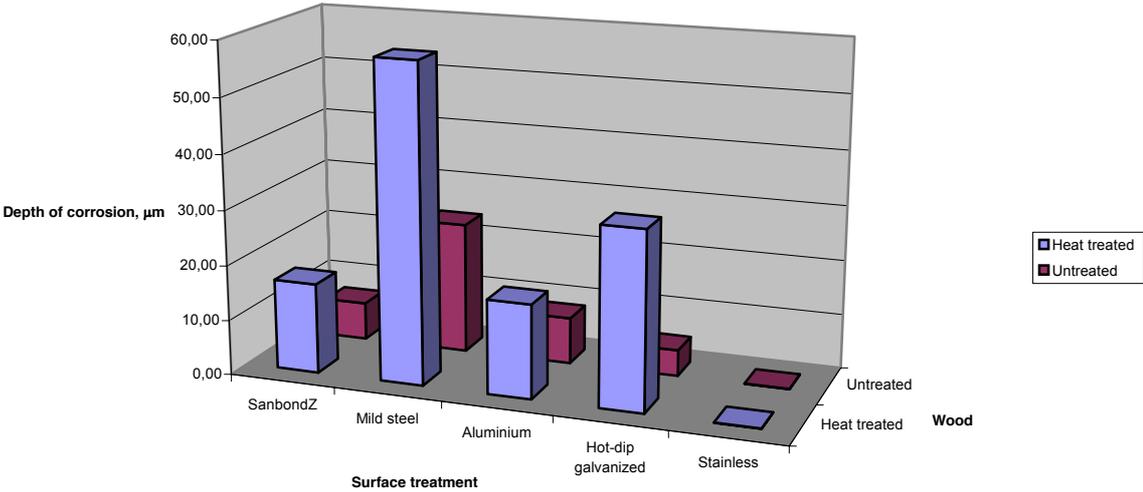
Figure 4. Depth of corrosion (µm) of fasteners in heat-treated and untreated wood after two years' exposure.

Although only two fasteners of each kind have been examined and the time of exposure was only two years, it seems as heat-treated wood is more aggressive to all metals and coatings tested but stainless steel than untreated wood. A possible explanation is the existence of residual acids, mainly acetic and formic acids (Bourgois and Guyonnet 1988, Manninen et al 2002, Tjeerdsma et al 1998, Sundqvist 2004), that are formed during the heat treatment. It has to be pointed out that the results from this study may not be valid for heat-treated wood in general but so far only for heat-treated wood treated according to the particular process applied.
