Thermal Treated Hardwood Floor Testing
NRRI Technical Note TN-2012/02
February 2012

Prepared For: Attica Millwork
71 Market Street
Attica, NY 14011

Objective: To conduct testing of end-jointed decking to understand the bending characteristics of an unsupported end-joint spaced at mid-span. The goal was to understand the deflection of the joint under a 300 pound proof load and to determine the maximum load at failure.

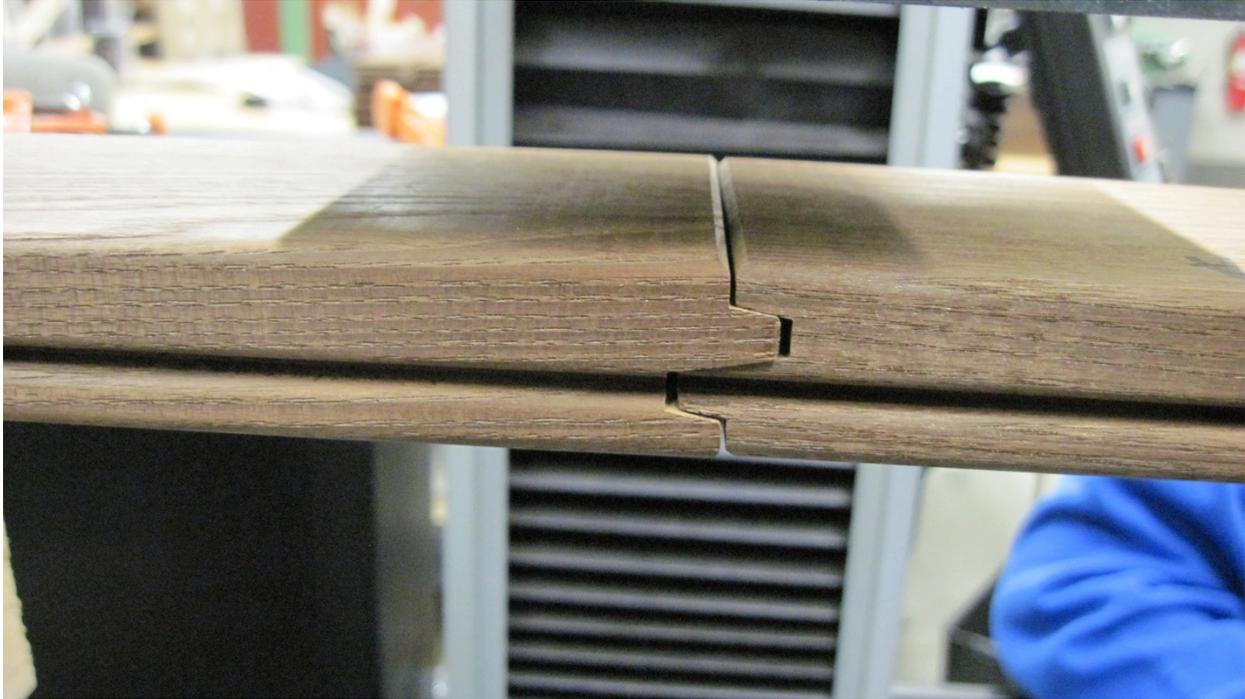
Figure 1.--End-joint tested to evaluate bending characteristics.

Samples: Thermal treated decking samples were provided to the Natural Resources Research Institute for evaluation of bending performance. The majority of the groups contained an end joint as shown in Figure 1. Control samples without and end joint were also tested. The groups that were evaluated included:

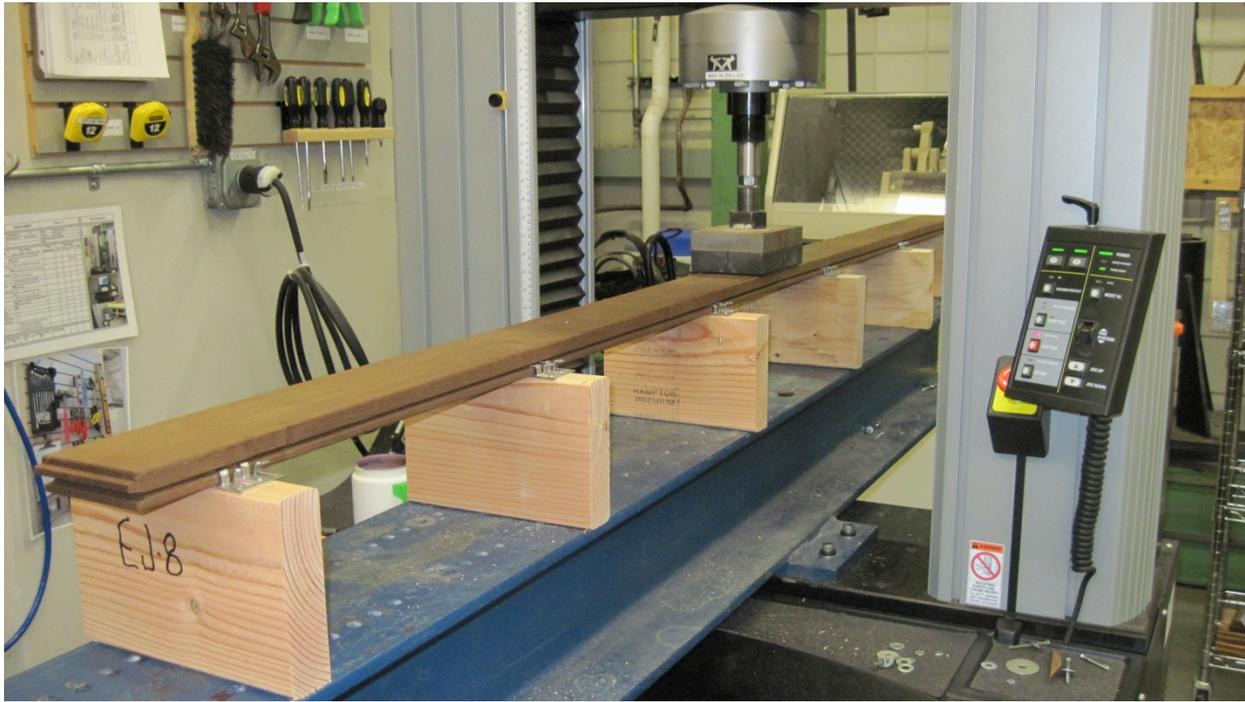
Figure 2.--Test setup showing decking spaced 16 in on-center with a 4- by 6-in. load surface above the end-joint. This sample was attached with clips attached to the joist edge and the decking groove.

between simulated wood deck joists spaced at 16-in. on-center. The decking joists were attached to the steel testing frame. To attach the samples, the decking was attached to the 2-by 6-in wood joists using clips or screws (Deckmate 8 by 2" star drive) provided by Attica Millwork. The sections were then attached to the testing machine so that the joints were placed directly under the loading head.

A 3-by 6 in. loading pad was placed over the end-joint. The load was applied to the sample at a controlled rate of 0.6 in./minute. The deflection was determined at a load of 300 pounds and the total load at failure was also recorded. The mode of failure was noted.

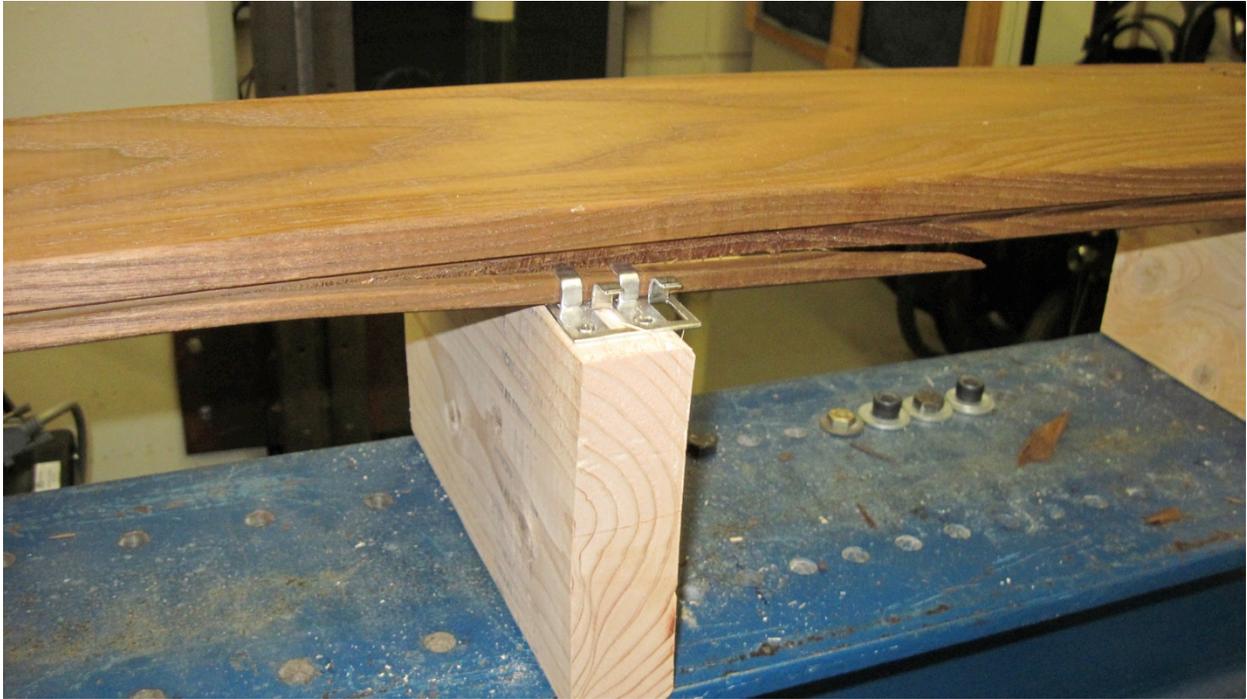
Figure 3.--Typical failure of lower tongue when decking installed with clips.

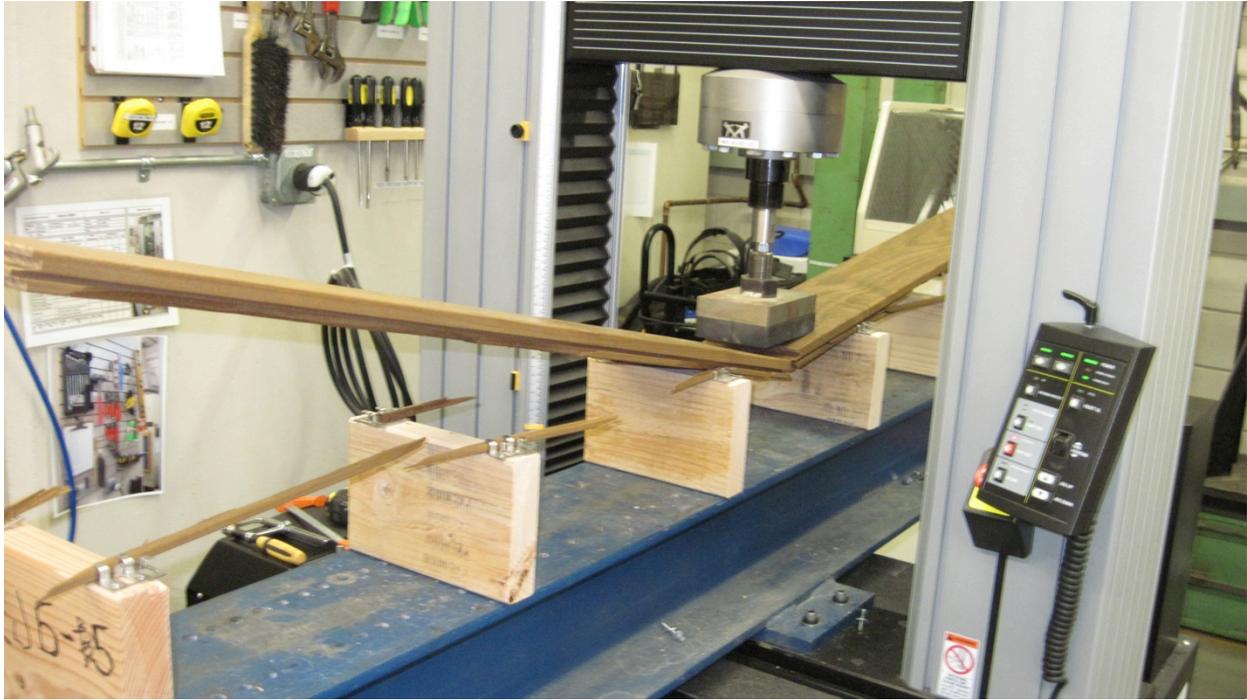
Figure 4.--Typical failure of decking when using clips. The lower tongues fail, resulting in the deck lifting significantly.

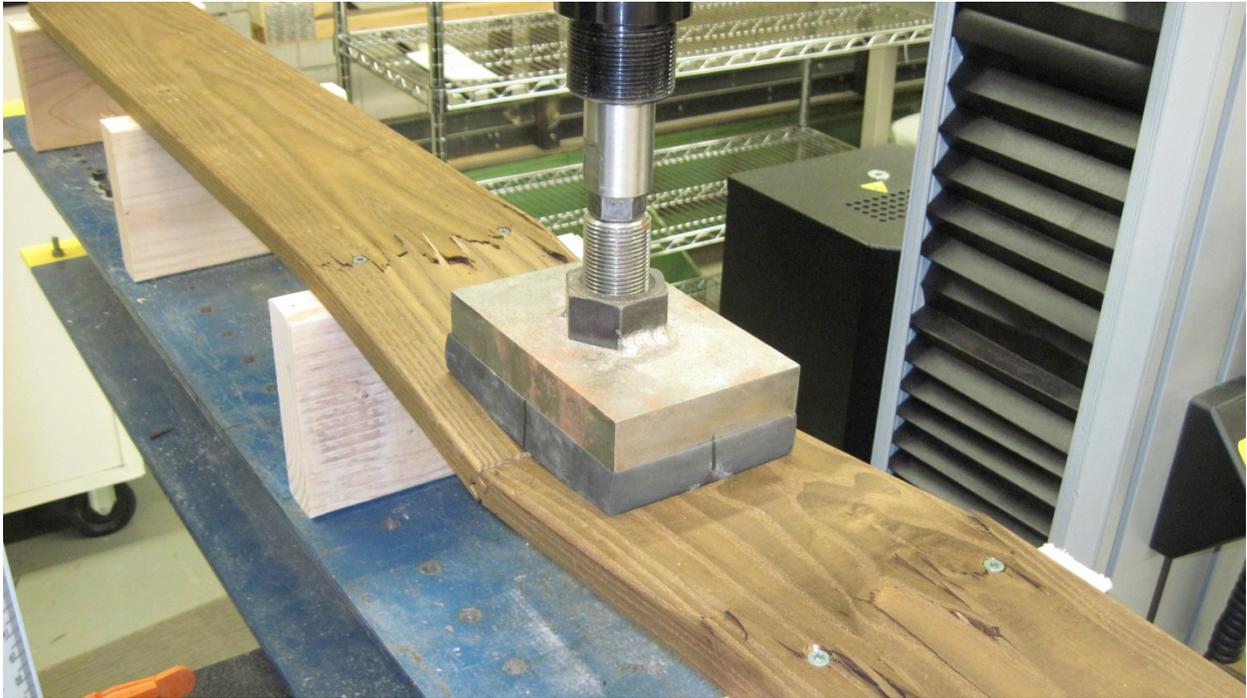
Figure 5.--Typical lumber showing failure mode. This sample was face-screwed to the joist edge.

Discussion: The testing was setup to simulate a person standing directly on top of an end joint. The goal was to determine the deflection of the joint under 300 pounds of force and to determine the maximum load at failure. There were two techniques used to attach the decking to the edge joist. For those samples where a side clip was inserted into a machined groove, the typical failure mode of the samples tested was that the bottom tongue split apart and failed. This can be seen in figures 3 and 4. For those samples with end-joints that were face screwed to the joist, the typical failure mode was lumber failure between the joists that were located on either side of the end-joint. This can be seen in figure 5.

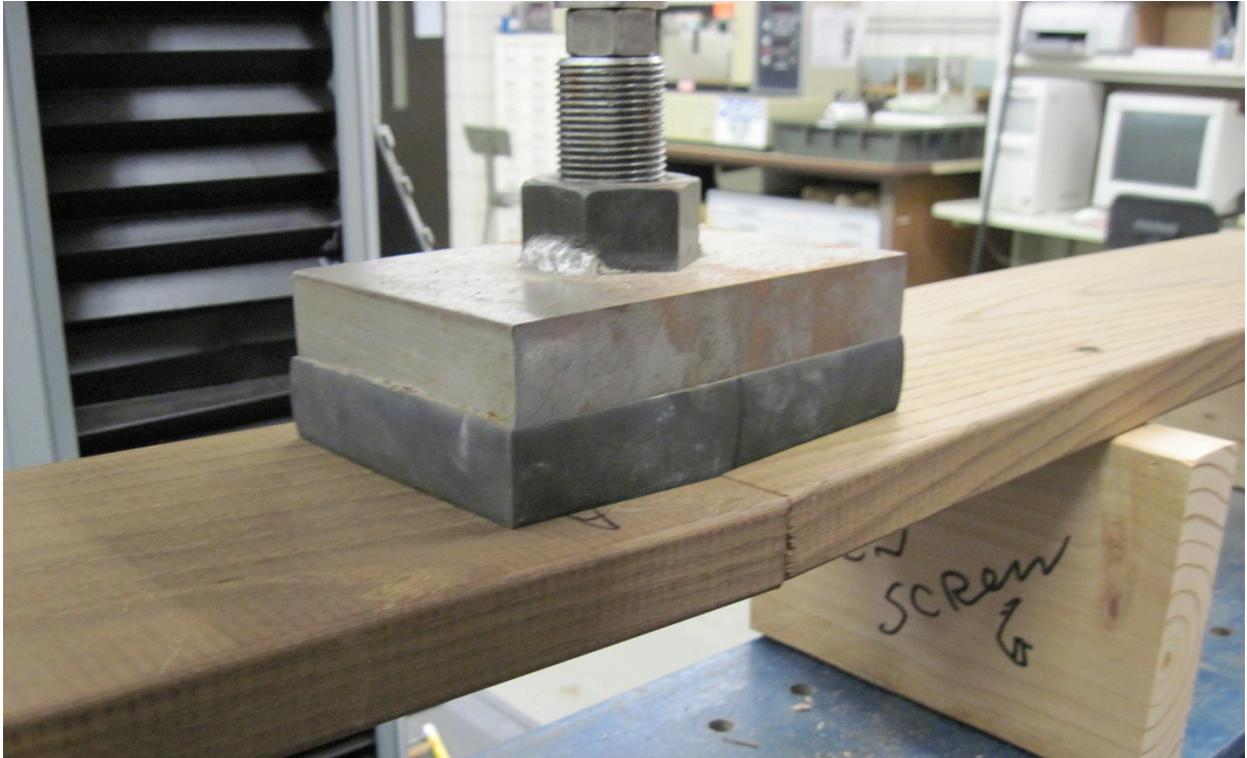
Figure 6.--Control specimen tested with butt joint at midspan.

Finally, several samples were tested to understand the performance of testing samples with just a butt joint or with no joint between joists. The butt-joint samples were tight together, and the compression of the samples may have enhanced the load characteristics, by reducing the deflection. The highest load at failure was for the samples that contained no joint between joists. Examples of the control samples are shown in figures 6 and 7.

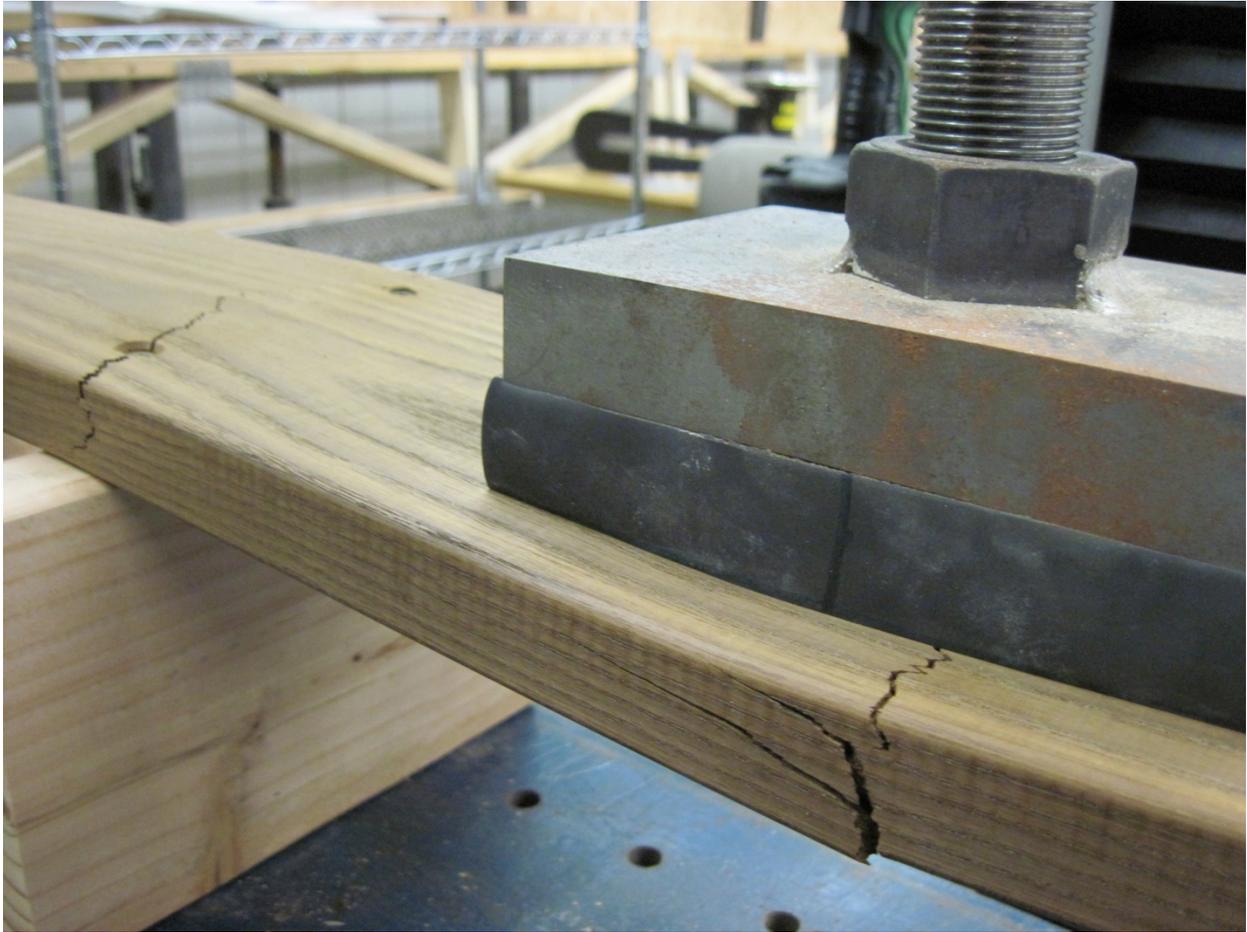
Figure 7.--Typical failure of a control sample without an end-joint under the load.
