Corrosion of fasteners in heat-treated wood – progress report after two years' exposure outdoors.

Jöran Jermer and Bo-Lennart Andersson
SP Swedish National Testing and Research Institute
PO Box 857
SE-501 15 Borås, Sweden

**Paper prepared for the 36th Annual Meeting
Bangalore, India
24-28 April 2005**

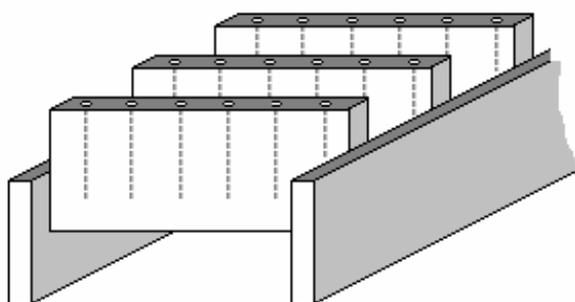
Figure 1. Sample set-up for corrosion testing.

Each fastener was washed in ethanol and then weighed, before being applied to samples of 45x145x500 mm, standing upright as in figure 1. The fasteners are thus tangentially oriented in the wood sample. The trial set-up is a modified set-up used by Boliden AB in a trial carried out in the 1970s (Berglund, Wallin 1978). A sealing compound was applied between fasteners of different materials to prevent galvanic elements from arising if water remains on the horizontal surface.
